RADC-TR-71-81 Technical Report December 1971 Jo 1473

BEARING IMPROVEMENT PROGRAM FOR LARGE ROLLING ELEMENT BEARINGS

Rome Air Development Center Air Force Systems Command Griffiss Air Force Base, New York

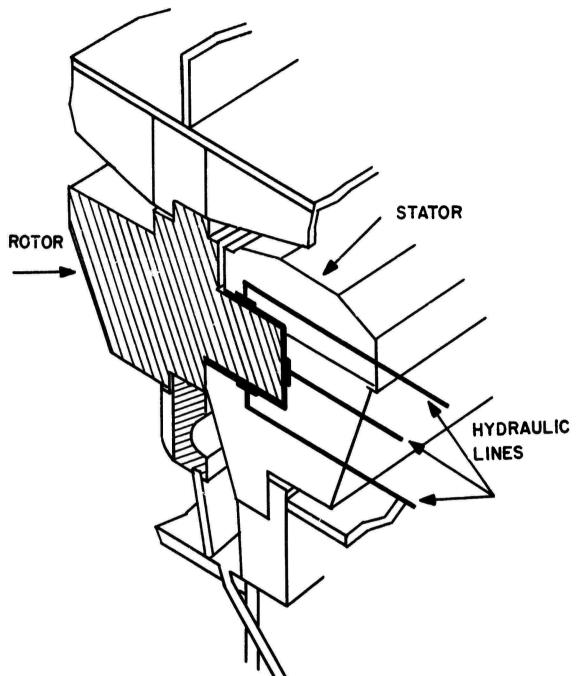
Figure 8. AN/FPS-24 Hydrostatic Bearing

The third effort was the development of a hydrostatic bearing for the AN/FPS-24. Because of the relatively high rotating weight and small bearing diameter in the pedestal for this radar, it was unlikely that satisfactory life could be achieved with a rolling element bearing. A different type of bearing was therefore considered. It consists of rotating and stationary surfaces which are separated completely by a thin film of flowing oil which is continuously supplied by an external pressure source. The surfaces were arranged to combine two thrust and one journal bearing in one unit. A cross-section of the bearing is shown in Figure 8. The advantages of this type of bearing for this application are:

The AN/FPS-24 hydrostatic bearing which was developed by Goodyear Aerospace Corporation was installed, tested, and successfully operated in the AN/FPS-24 radar at Oakdale, Pennsylvania. The test was terminated by catastrophic failure after 7821 hours of operation. The failure was due to human error which caused fail-safe drive brakes to be disabled, followed by interruption of prime power to the site. The details of this effort are contained in Reference (1).

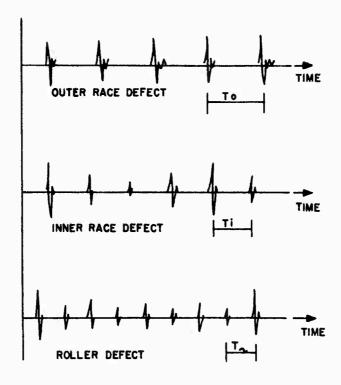
Figure 20. Bearing Malfunction Signatures

Several techniques were used to analyze the vibration data. The simplest technique was direct viewing of the raw data by means of an oscilloscope or an oscillograph. When a spall has formed on either the inner race, outer race, or rolling element of a bearing, an impact is generated whenever the spalled area is contacted. Figure 20 shows the basic bearing malfunction signatures. The time between impacts can be calculated by knowing the rotational speed, size of the bearing, and size and number of rolling elements. Unfortunately, extraneous signals from other sources tend to mask the impact signals.

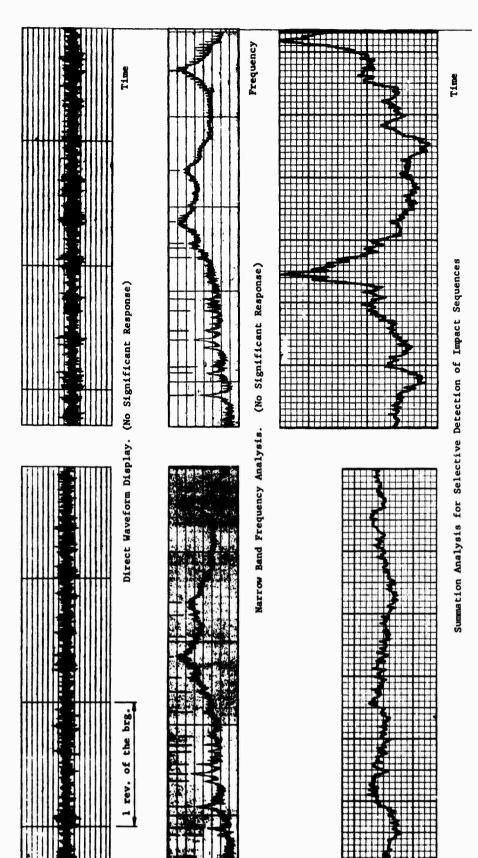
Figure 22. Comparison of Three Methods of Vibration Analysis

The third technique that was used was a summation analysis. The vibration signal is divided into several segments of a length which corresponds to the period of the defect impacts, T_S . The segments are then summed. The effect of this summation is an enhancement of the signal-to-noise ratio of disturbances having periodicity T_S over the signal-to-noise ratio of the raw signal. Figure 21 shows the summation technique and a block diagram of the analysis equipment. Figure 22 shows the results of a comparison of the three detection methods for detection of a small defect.

disassembled, it was found to have two small spalls distributed over an area approximately ¼ inch by ¼ inch on the stationary ball race. The fact that the two spalls did not generate a measurable vibration signature can probably be traced to the following reasons:

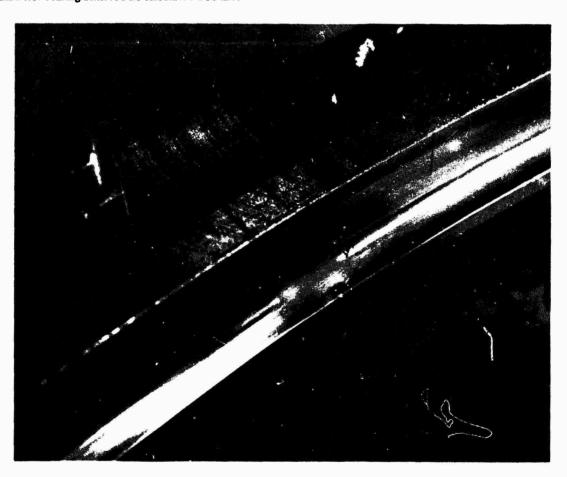
Figure 23. Outer Race of Test Bearing No. 3, Showing Fatigue Damage

The combination ball-roller bearing has a calculated B10 life of 191,127 hours under field conditions. Note that the calculated life of the combination ball-roller bearing is less than that of the "X" bearing. Calculations of B10 life under accelerated test conditions indicated a life of 1095 hours for the two-row bearing. Therefore, the third test bearing achieved its calculated B10 life.

Thus, from the test results it appears that the combination ball-roller bearing is capable of achieving a much greater percentage of its calculated life in this application than previous bearings. In fact it should approach its B10 life of 191,127 hours for field conditions if the higher viscosity lubricant could be used. An additional factor which indicates that the new bearing would be superior to previous bearings is that the high overturning moment that existed for the test very seldom occurs in the field. This overturning moment is taken by the ball row. It was the ball row that failed in both test bearings. The rollers and roller races did not show any signs of failure under test conditions. Under field conditions, the rollers would carry most of the operational loads.
